Manhole Inspection Summary

Manhole # S29YY_006MH

Location Address: **3401 34TH ST**

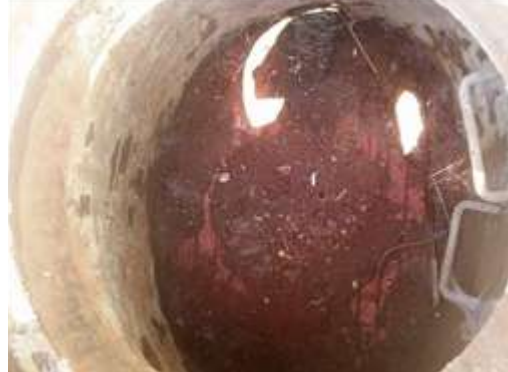
Top View

Channel debris.

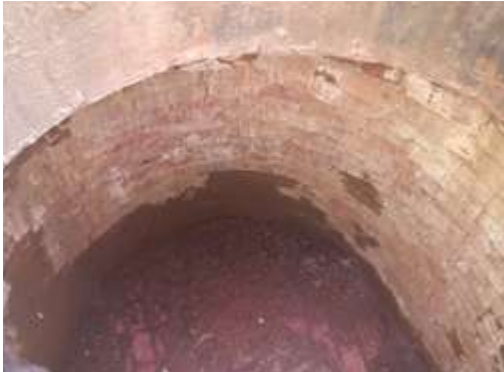
Defect

Frame leaks. Adjustment and Barrel infiltration.

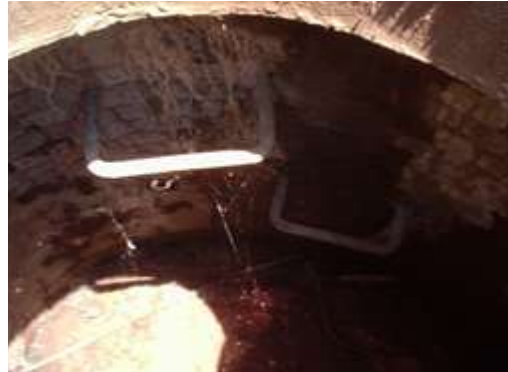
Defect

Frame leaks. Adjustment, Corbel and Barrel infiltration.

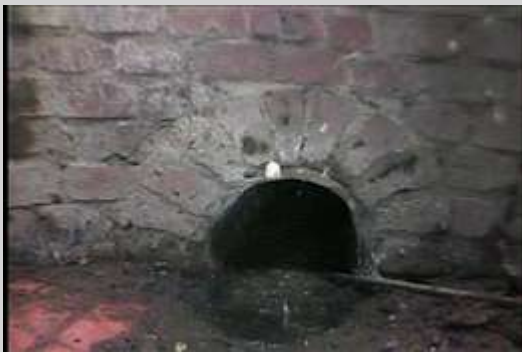
8 in. Circular Gravity Sewer
Pipe Out @ 12 O'Clock

Deposits: ☐ None ☒ **Mud** ☐ Sludge ☒ **Debris** ☐ Grease

Silt Depth: **0.5** (in.) Deposits Extent: **Light**

Infiltration: **Evidence** Pipe Seal Cond: **Unknown**
